BELZONA PROVIDES CONSISTENT SUPPLY OF PULVERIZED FUEL

Application: SHM-Solids Handling Machinery

Customer Location: Thermal Power Plant, Northern Italy

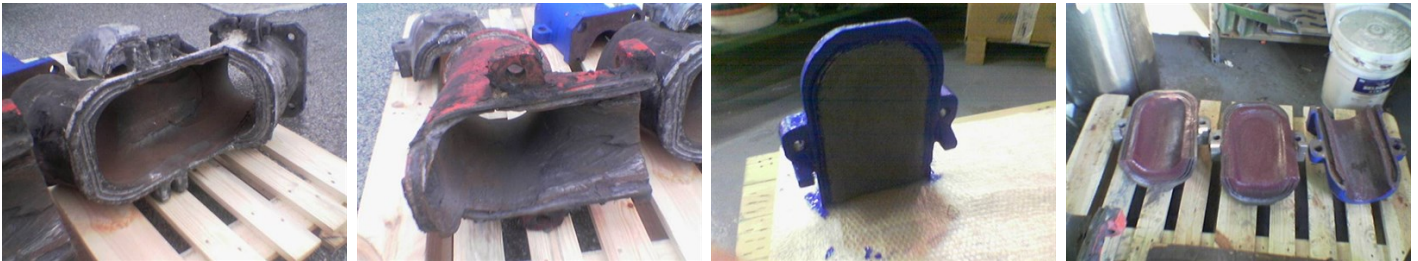
Photograph Descriptions

Dry abrasion from coal particles in pneumatic system causes wear at bends, curves and direction transitions.

- * A large bend ,
- * An L shaped curve ,
- * Completed cover ,
- * More bend covers protected with Belzona ,

Application was carried out in accordance with Belzona Know-How System Leaflet SHM-13. The replaceable covers for transition points are routinely filled with the Belzona.

No more random failures, Normally they last from August to August before being routinely relined. Occasionally Belzona® 1811 needed for small patch repairs. The engineers have tried welding and other materials but Belzona repairs provide the most consistent performance.
