# BELZONA PROVIDES CONSISTENT SUPPLY OF PULVERIZED FUEL

ID: 1073

Application: SHM-Solids Handling Machinery

Customer Location: Thermal Power Plant, Northern Italy

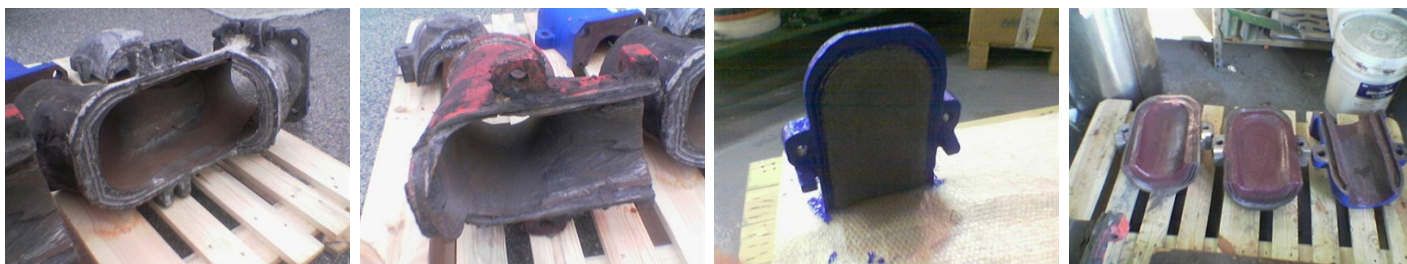
*Dry abrasion from coal particles in pneumatic system causes wear at bends, curves and direction transitions.*

- \* A large bend ,
- \* An L shaped curve ,
- \* Completed cover ,
- \* More bend covers protected with Belzona ,

Bends and curves in pneumatic conveyor system.

Application was carried out in accordance with Belzona Know-How System Leaflet SHM-13. The replaceable covers for transition points are routinely filled with the Belzona.

No more random failures, Normally they last from August to August before being routinely relined. Occasionally Belzona® 1811 needed for small patch repairs. The engineers have tried welding and other materials but Belzona repairs provide the most consistent performance.
