# BELZONA ELASTOMER MAKES MECHANICAL SEAL REFURBISHMENT EASY

ID: 1074

Customer Location: Hydroelectric plant, Italy  
Application Date: Ongoing for 20 years

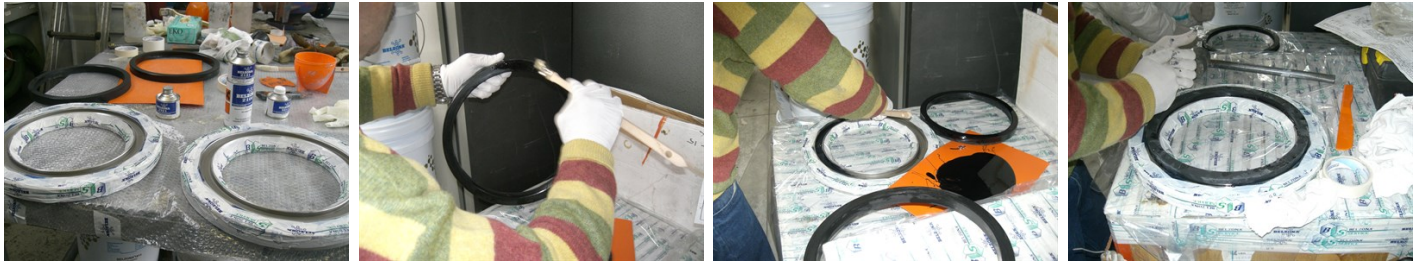
- \* Protecting and blasting steel support ,
- \* Rubber ring being Conditioned ,
- \* Conditioner applied to metal support ,
- \* Rubber ring bonded in place with Belzona Elastomer ,

Mechanical Seal from hydroelectric turbine

Application carried out in accordance with Belzona Know-How System Leaflet GSS-2. Rubber ring bonded in place with Belzona® 2111 then re-machined to precise tolerance. Steel substrate is masked off and bond face grit blasted prior to bonding rubber ring in place with Belzona Elastomer.
