# BELZONA FLEXIBLE MEMBRANE SEALS LEAKING CONCRETE DECK

ID: 1077

Industry: *Buildings & Structures*  
Application: *RPA-Roof Problem Areas*  
Substrate: *Exposed aggregate concrete*  
Products: *Belzona® 3111 (Flexible Membrane)*

Leaking concrete deck over parking garage

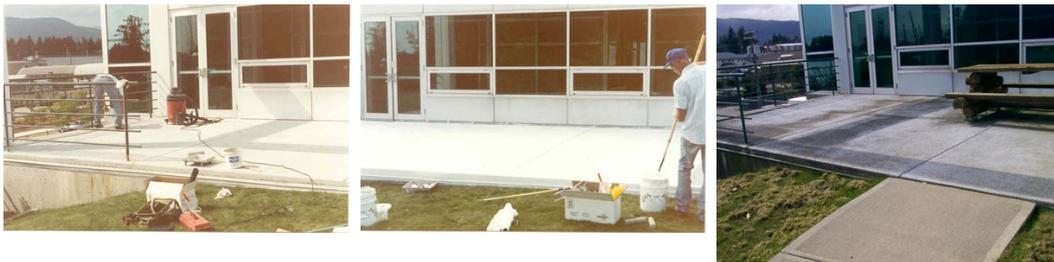
## Photograph Descriptions

*Water, leaking through the concrete deck, was falling on the cars parked beneath and damaging the paintwork*

\* The deck prepared by pressure washing , \* After application of Belzona® 3911 to concrete surfaces and Belzona® 3921 Aluminum surfaces (window and door frames), Belzona® 3111 was applied , \* View of deck taken in 2005 after 10 years of service ,

Application completed in accordance with a modified version of Belzona Know-How System Leaflet RPA-10.

Various crack sealing products had been tried with little little to no success.  
A recent check in 2008 reveals the deck coating to still be in service.
