BELZONA REPAIRS LEAK IN HOT ACID PIPELINE

ID: 1079

Industry: General Industry
Application: VPF-Valves, Pipes and Fittings
Substrate: Cast Iron
Products: <div>Belzona® 1311 (Ceramic R Metal)</div><div>Belzona® 4301 (Magma CR1 Hi-Build)</div>
Customer Location: Zinc Smelter - British Columbia
Application Date: 2007

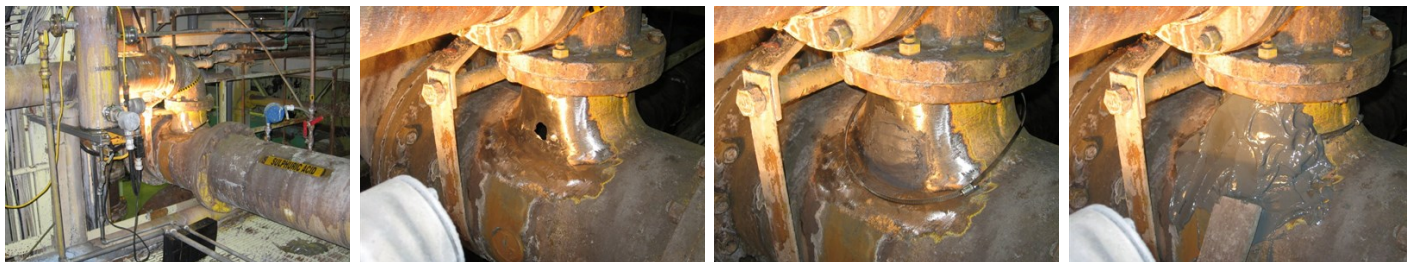
Photograph Descriptions

A cast "T" junction had developed a large hole and a replacement unit was several weeks away

* Overview of application situation , * The hole in the valve is prepared by grinding , * Completed application of 1st patch using Belzona® 1311 , * Completed application with fina patch of Belzona® 4301 and steel plate bonded in place ,

Cast valve handling hot Sulphuric acid

Application was carried out in accordance with Belzona Know-How System Leaflet VPF-11a

With no replacement valve available production relied on the success of the Belzona repair which lasted until the new valve arrived some weeks later.
