BELZONA ELASTOMER SEALS CONCRETE PARKING DECK

ID: 1080

Industry: *Buildings & Structures*
Application: *FPA-Floor Problem Areas*
Substrate: *Concrete*
Products: ** Belzona® 2221 (MP Fluid Elastomer),*

Customer Location: *Shopping Mall - Vancouver, BC*
Application Date: *November 2007*

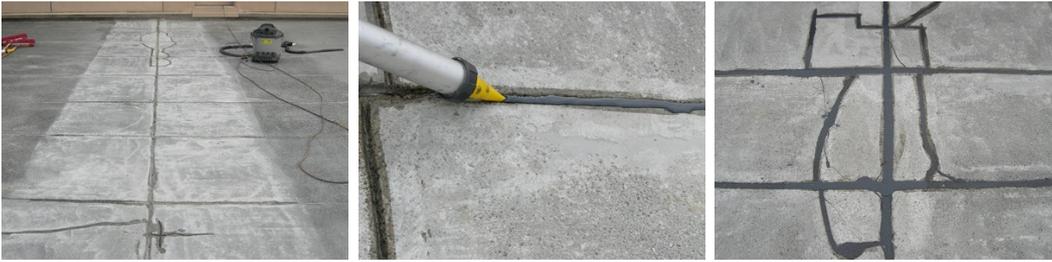
A previous application by another contractor had failed in a very short space of time leading to water entering the shop below.

- * All joints were ground clean to remove all traces of the failed material ,
- * All joints were conditioned with Belzona® 2911 prior to injecting the Elastomer ,
- * Completed application with all the joints and cracks sealed ,

Various cracks and faulty seams on concrete parking deck.

Application was carried out in accordance with Belzona Know-How System Leaflet FPA-6.

Heavy rains after the application had been completed revealed that the area was now completely water-tight.
