RESEATING NEW RUDDER BUSH WITH BELZONA

ID: 1083

Customer Location: *Ship Dockyard, Bulgaria*
Application Date: *November 2007*

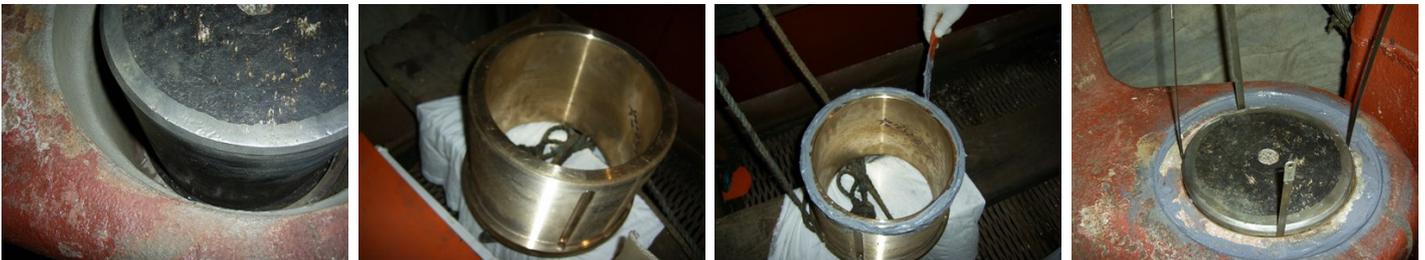
Photograph Descriptions

Corrosion damages and wear led to increased annular space between the bush and its housing and irregular form of the bush housing.

- * The housing prepared by blasting and ready for bush assembly. ,
- * The new bearing bush prepared with thread profile and longitudinal channels to accommodate plastic pipes for injection and to serve as locking keys to prevent bush rotation. ,
- * Sealing the bottom of the new bush with Belzona® 1221. ,
- * Completed application. Belzona® 1321 completely filled annular space. Pintle with metal shims were used for bush alignment. ,

Installation of new pintle bearing bush in worn pintle bearing housing.

Belzona saved time and money against an expensive machining of the housing and supply of larger bush. No alternative was fast enough to compete. This standard repair procedure eliminates galvanic corrosion and provides long term location of the bush.
