BELZONA PROVIDES CAVITATION PROTECTION TO PUMP IMPELLER

ID: 1091

Application: CEP-Centrifugal Pumps

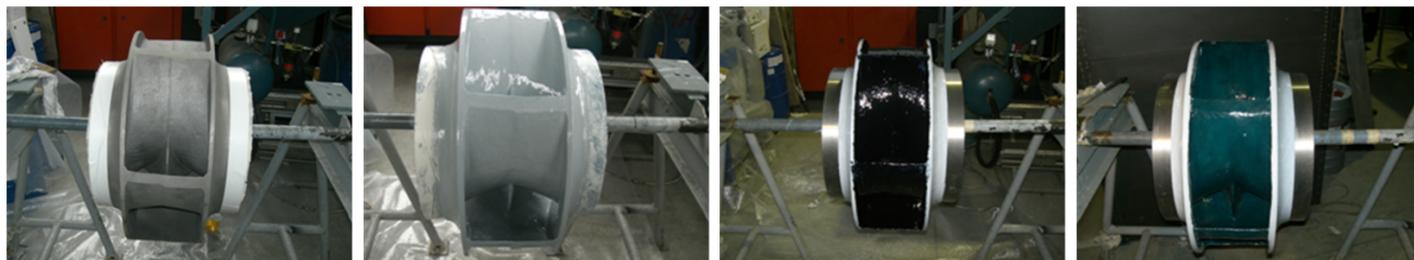
Photograph Descriptions

Impellers lasting only 6 months before showing heavy cavitation leading to excessive noise and ultimately loss of balance necessitating replacement.

* Blasted Surface , * Coated with Belzona® 1341 , * First coat of Belzona® 2141 (black) applied , * Application completed with a second coat of Belzona® 2141 (green) ,

Coating for new impeller

Application was carried out in accordance with Belzona Know-How System Leaflet CEP-3

Original impellers being replaced after 6 months. Belzona coated impeller inspected after more than one year and still in excellent condition.
