BELZONA PROVEN PROTECTION ON TURBINE RUNNER

ID: 1092

Francis Turbine runner for a Hydro Electric Plant in Africa.

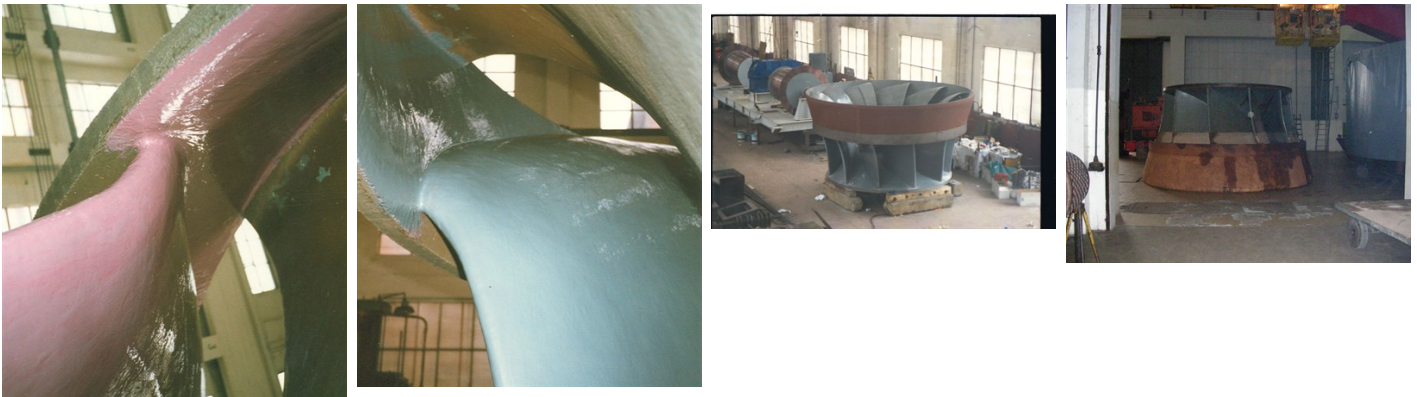
Photograph Descriptions

Coating protection required to deal with anticipated Erosion and Corrosion.

- * First coat ,
- * Second Coat applied ,
- * Completed Application ,
- * Coating after 20 years in service ,

The customer contacted the Distributor in September 2007 for a general inspection of the coating which indicated repair was

needed in areas. A proposal to refurbish with Belzona® 1321 has been made.
