# BELZONA REPAIRS INJECTION PIPES IN FGD UNIT

ID: 1093

Customer Location: Power Station, Thailand

Application Date: November 2005 & 2007

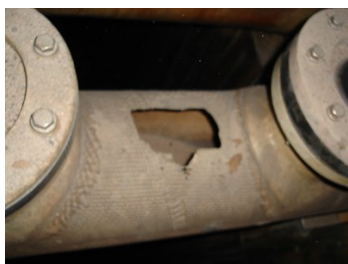
Limestone slurry is injected through the nozzles. This falls on the GRP pipeline connecting the nozzles causing holes

- \* Typical damage to the pipework ,
- \* Surface preparation being carried out ,
- \* Application being carried out ,
- \* Completed application ,
