BELZONA REPAIRS INJECTION PIPES IN FGD UNIT

ID: 1093

Customer Location: Power Station, Thailand
Application Date: November 2005 & 2007

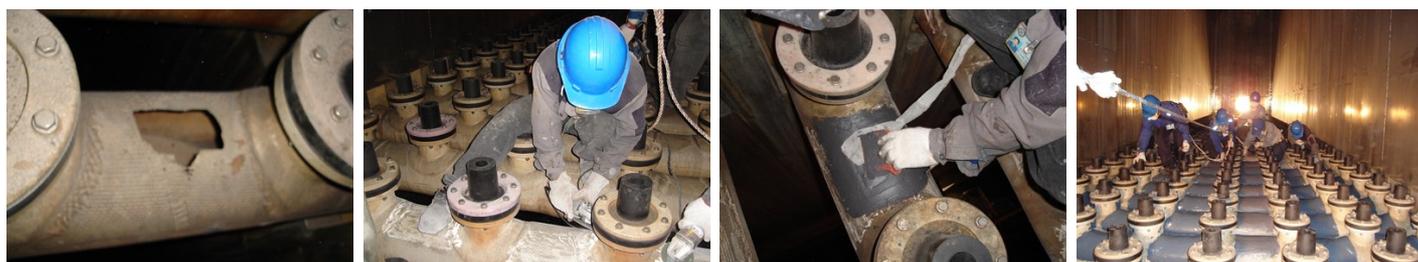
Photograph Descriptions

Limestone slurry is injected through the nozzles. This falls on the GRP pipeline connecting the nozzles causing holes

- * Typical damage to the pipework ,
- * Surface preparation being carried out ,
- * Application being carried out ,
- * Completed application ,

Application carried out in accordance with Belzona Know-How System Leaflet VPF-11a. Belzona® 1812 used to repair holes then overcoated with Belzona® 1391

Originally Belzona® 1311 used to repair pipes but after 2 years Belzona® 1391 worn away and part of the Belzona® 1311 exposed. Redone with Belzona® 1812. This system performed significantly better and after 2 years was reported to be more than 80% intact.
