# BELZONA GETS TRACTOR BACK ON TRACKS

ID: 1094

Rubber tractor tracks

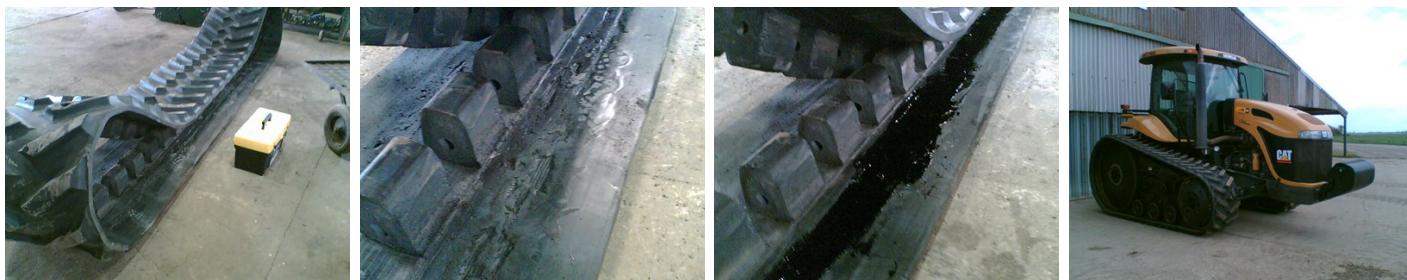
*Abrasion of rubber on inside surface of tracks*

\* General view of track before repair , \* Close up of damaged area , \* After repair , \* Back on track ,

Application was carried out in accordance with Belzona Know-how System Leaflet SHM-1.

Belzona is the approved repair method by Manufacturer. Whole repair will cost £250. New tracks cost £5500.
