# BELZONA GIVES SECOND LIFE TO POLYMER CONCRETE TANK

ID: 1097

Customer Location: Power Plant, Russia

Application: TCC-Tanks and Chemical Containment Areas

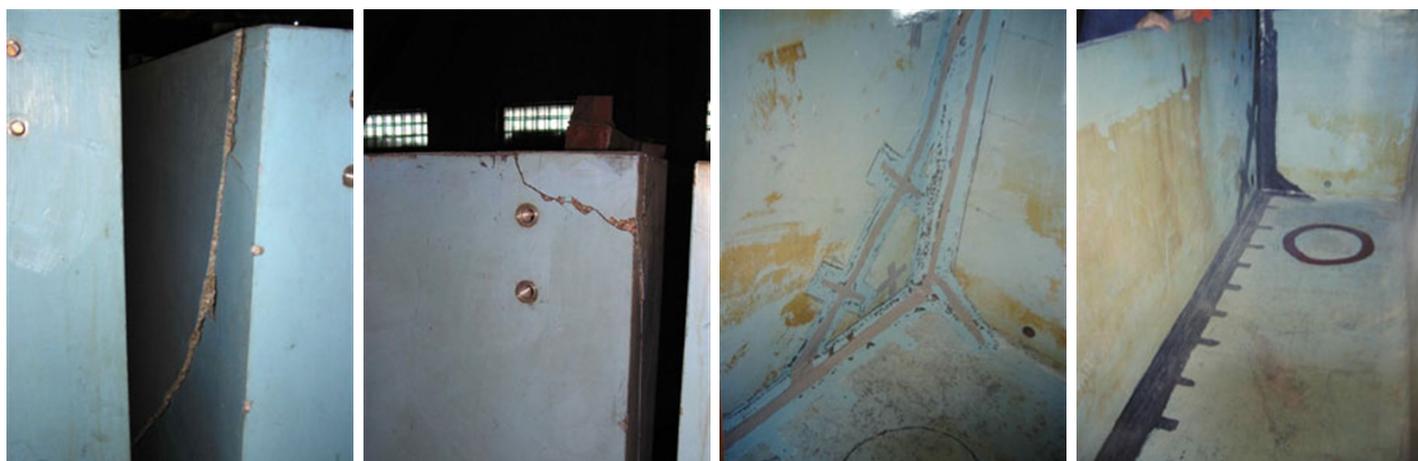
## Photograph Descriptions

Incorrect maintenance caused cracks to develop in several tanks and leakages of acid onto the floor. Every tank costs more than 15000 USD. Two of the tanks lost their integrity as both had large parts of wall broken off and were ready to be condemned.

\* Fatal damage to the tank , \* Another tank is destroyed , \* Belzona® 4111 after application , \* Belzona® 4341 after application ,

Polymer concrete tanks reinforced with fiberglass containing 22% sulfuric acid at 60°C in water treatment shop.

Application was carried out in accordance with Belzona Know-How System Leaflets TCC-7 & -9.

On the completion of the repairs the tank was tested under load and did not show any traces of leakage. After 3 year operation tank is in excellent condition. Total job took two weeks and customers spent 6000 USD on it.
