BELZONA PROTECTS WASTE WATER TANK

ID: 1098

Customer Location: Pulp Factory, Southern Germany
Application Date: June to December 2007

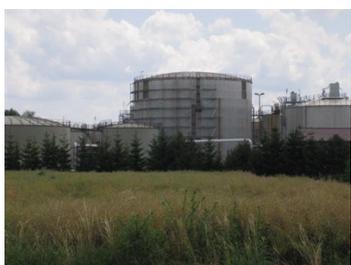
- * 10600cbm tank ,
- * Welded steel plates during crack testing ,
- * Rebuilding of pitted surface with Belzona® 1121 ,
- * Hot sprayed surfaces with Belzona® 5811 before scaffold was taken out ,

10,600 cubic metre waste water tank with inner surface of 3000m² containing waste water from pulp production.

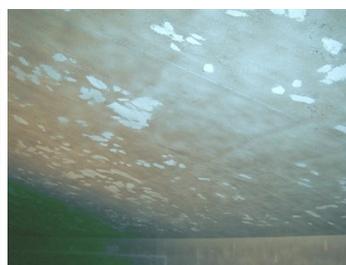
Tar epoxy coating had failed especially in vapour phase due to limited chemical resistance against Sulfite solutions. Corrosion had led to more than 1000 holes in roof and leaks in side walls.

Failed coating was removed by ultra-high pressure water jetting and grit blasting. Steel plates were welded in tank to guarantee mechanical integrity. Rebuilding of pitted steelwork carried out in accordance with Belzona Know-How System Leaflet TCC-5. Coating by heated airless spray in 2 layers.
