BELZONA REPAIRS AND PROTECTS ROOF

ID: 1099

Customer Location: *Public Gymnasium, France*
Application Date: *July 2002*

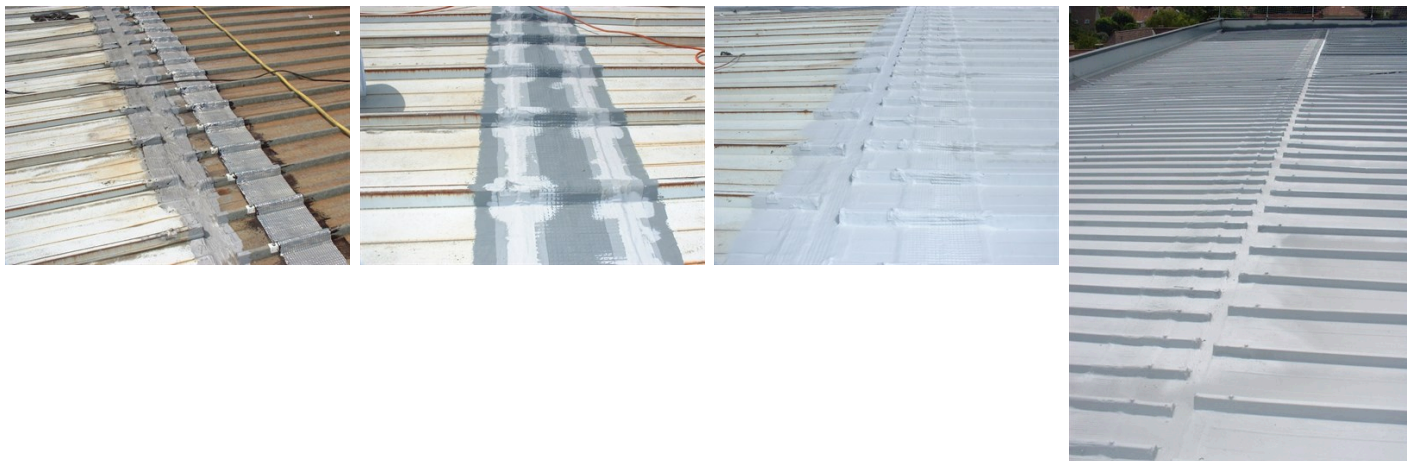
Photograph Descriptions

Localised leakage and overall corrosion problem

* Localised water ingress , * Repair to the seams , * Application extended to cover Corroded roof , * Application completed ,

Localised repairs carried out in accordance with Belzona Know-How System Leaflet RPA-1. Further corrosion protection achieved by spray application of Belzona® 3111 system.

Belzona solution stopped the water ingress into the sports facility and also gives corrosion protection to the overall steel surface.
