# BELZONA PROTECTS EVAPORATORS IN DISTILLATION UNIT

**Industry:** Oil & Gas  
**Application:** TCC-Tanks and Chemical Containment Areas  
**Substrate:** Stainless steel 317L  
**Products:** \* Belzona® 1391 ,

**Customer Location:** National Oil Company  
**Application Date:** May 1996

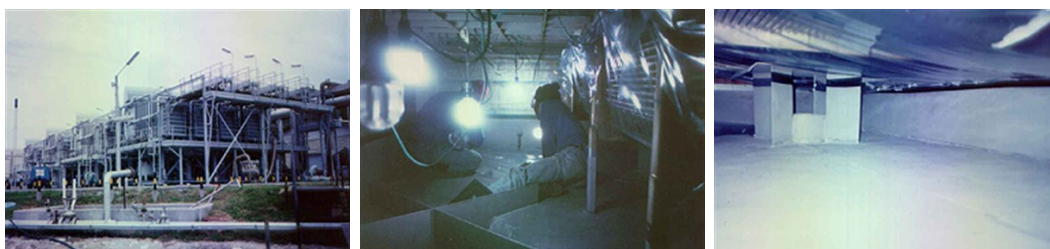
Floor plate in No. 4 Distillation unit was showing considerable corrosion and weld repairs, including welding in of new plate sections had already been carried out previously.

- \* General view of the 4 Distiller units. ,
- \* Work underway inside the Evaporator. Note low temperature lighting used to minimise air temperature. ,
- \* Belzona® 1391 applied to base and 30cms up side of all steelwork in unit. ,

Application was carried out in accordance with Belzona® Know-How Leaflet TCC-3. Extreme care was taken to ensure all salt contamination was removed and de-humidification equipment installed to prevent moisture contamination during application.

Recent inspection has shown Belzona® 1391 in perfect condition and customer can now look forward to many years service from the units without constant shut-downs for weld repairs. The other 5 units will also be coated shortly with Belzona® 1391.
