BELZONA PROVIDES SAFE WELCOME

Industry: *General Industry*
Application: *FPA-Floor Problem Areas*
Substrate: *Floor tiles*
Products: ** Belzona® 1321 (Ceramic S Metal) ,*

Customer Location: *Manufacturer, Slovakia*
Application Date: *2008*

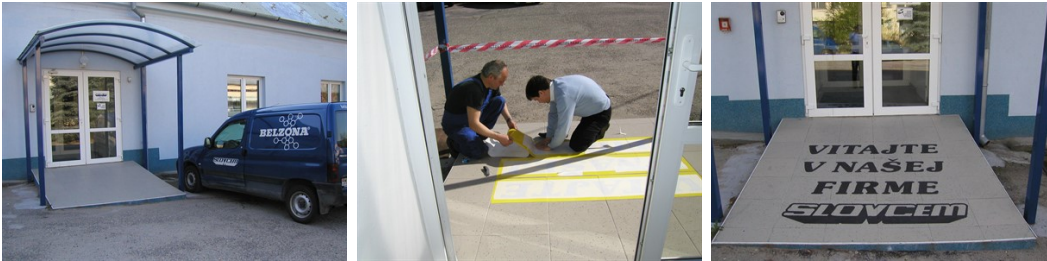
Photograph Descriptions

During rain or snow people have slip problems on the ramp into the offices.

- * Ramp entrance ,
- * Templates being placed ,
- * Completed application ,
- ,

The application was carried out in accordance with Belzona Know-How System Leaflet FPA-8. Belzona® 1321 was applied by brush in conjunction with Belzona® 9211 (Supergrip Aggregate). Templates were used to create logo.
