BELZONA EXTENDS LIFE OF CHILLER

Application: HEX-Heat Exchangers

Customer Location: International Airport, Stockholm

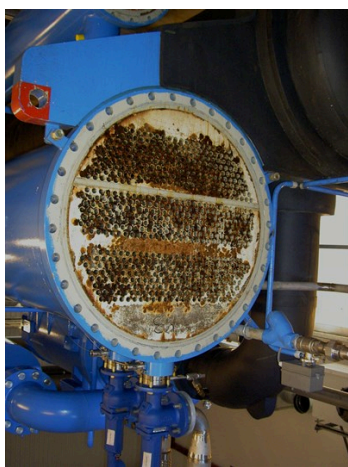
- * General view ,
- * Close up of erosion on tubesheet ,
- * Steam cleaning ,
- * Completed application ,

Three chiller units for air conditioning of terminal buildings.

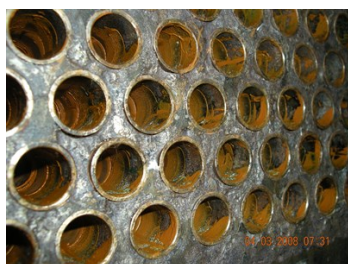
Corrosion on tubesheets (4) from one of the chillers was noticed in 2005. Cooling water comes from a local lake which together with galvanic effects was the cause of the corrosion.
