BELZONA EXTENDS LIFE OF CHILLER

ID: 1103

Application: HEX-Heat Exchangers

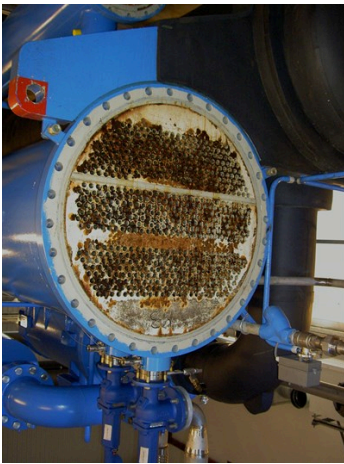
- * General view ,
- * Close up of erosion on tubesheet ,
- * Steam cleaning ,
- * Completed application ,

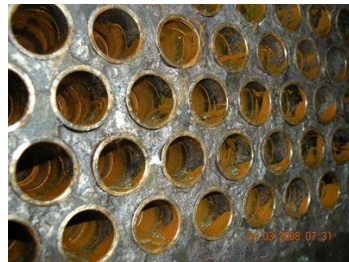
Corrosion on tubesheets (4) from one of the chillers was noticed in 2005. Cooling water comes from a local lake which together with galvanic effects was the cause of the corrosion.
