BELZONA EXTENDS LIFE OF CHILLER

ID: 1103

Industry: Heating, Ventilation & Air Conditioning

Application: HEX-Heat Exchangers

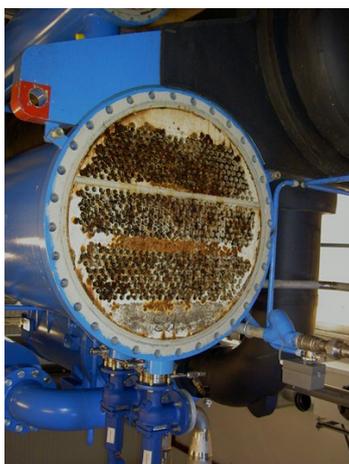
- * General view ,
- * Close up of erosion on tubesheet ,
- * Steam cleaning ,
- * Completed application ,

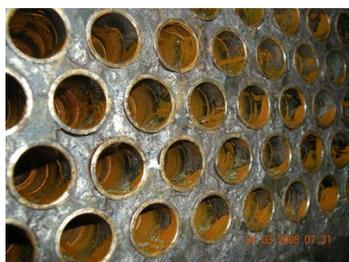
Corrosion on tubesheets (4) from one of the chillers was noticed in 2005. Cooling water comes from a local lake which together with galvanic effects was the cause of the corrosion.
