# BELZONA EXTENDS RUBBER PUMP LINER LIFE

ID: 1104

Industry: Power  
Application: CEP-Centrifugal Pumps  
Substrate: Rubber  
Products: Belzona® 2121 (D&A Hi-Coat Elastomer)

Customer Location: Power Station, Poland  
Application Date: 2005

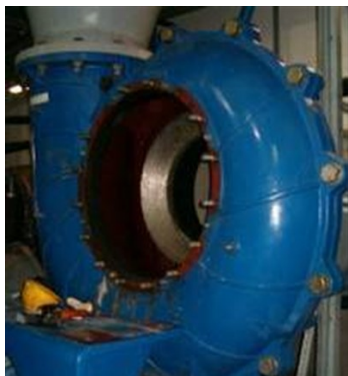
\* General view of the pump , \* First coat applied , \* Second coat , \* completed application ,
