BELZONA TEMPORARY SOLUTION TO A SERIOUS PROBLEM STILL IN SERVICE 10 YEARS LATER

ID: 1106

Application: *FPA-Floor Problem Areas*

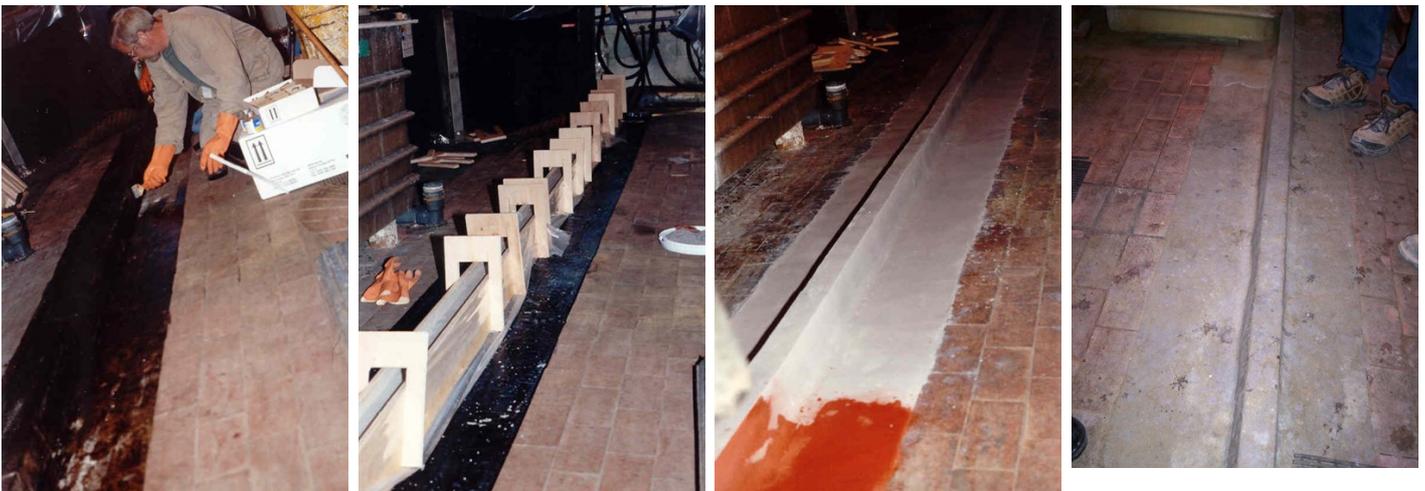
Photograph Descriptions

* The cracked membrane was repaired with two coats of Belzona Elastomer , * A pony wall was built using Belzona® 4131 , * The entire rebuilt area was overcoated with two coats of Belzona® 4311 , * View of the repair taken 10 years later showing it to be still in excellent condition ,

Customer had received a violation certificate for cracks in the floor and damage to a rubber membrane beneath a chemical plating facility

Application was carried out in accordance with Belzona Know-How System Leaflets FPA-3, -5 & -6. Rubber membrane was sealed with Elastomer and low retaining wall (pony wall) was constructed.
