BELZONA PROTECTS BLOWER HOUSING FROM CHEMICAL ATTACK

Customer Location: *Zinc Smelter - British Columbia, Canada*
Application Date: *2007*

Substrate: *Cast Iron*
Products: ** Belzona® 4341 (Magma CR4) ,*

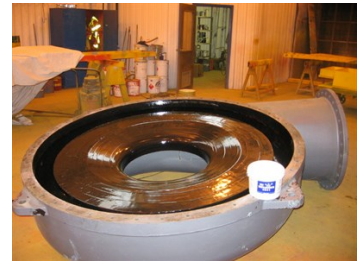
Hot acid mist was attacking the unprotected cast iron casing.

- * The blower housing grit blasted and ready for application ,
- * The backing plate grit blasted and ready for application ,
- * Blower housing with 1st coat of Belzona® 4341 (Red) applied ,
- * Blower housing with 2nd coat of Belzona® 4341 (Black) applied ,

Application was carried out in accordance with Belzona Know-How System Leaflet FBC-2.

The original housing had developed a leak and had been repaired by the customer with Belzona® 1111 (Super Metal) as an emergency repair until a new housing arrived. The temporary repair was so effective the new housing was put into the stores for more than a year before replacement was finally scheduled.
