BELZONA PRODUCTS USED TO SEAL LEAKING TANK

ID: 1109

Leaking concrete stock tank

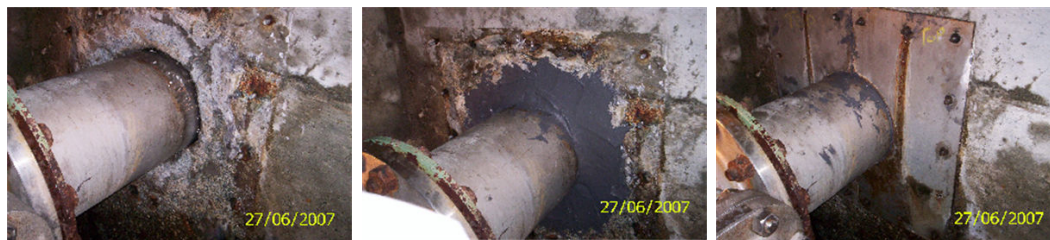
Photograph Descriptions

Mill had experienced a constant leak between the concrete wall of the stock tank and the steel outlet pipe

* Preparation of both the concrete and metal surfaces underway , * Belzona® 1311 forced into the gap between the pipe and concrete , * The back of the metal plate was coated with approximately 1/4 inch of Belzona® 1311 before it was bolted against the wall and the excess material squeezed out was wiped away ,

Application was carried out using modified versions of Belzona Know-How System Leaflets TCC-1 and VPF-11a. Bolted doubler plates were used to help form seal.
