BELZONA BECOMES A PERMANENT FIXTURE ON PUMPS

ID: 111

Customer Location: Power Plant in Virginia
 Application Date: April 1992

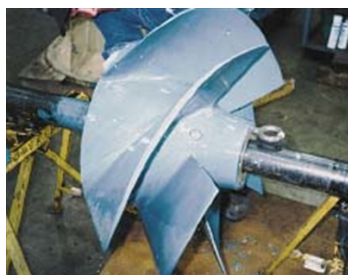
The pumps were exhibiting premature wear patterns which were not expected to happen until after 15 years of operation.

* Application of Belzona® 1341 to a diffuser bowl begins. Finishing touches to an impeller shown here. Flow diverters and all internal components were protected with Belzona® 1341. ,

The application was carried out in accordance with Belzona Know-How Leaflets CEP-3, CEP-5.

Three pumps were rebuilt in 1992. In 1995, one pump was pulled out of service, and after three years of operation, the Belzona® 1341 coating was still in excellent condition and required no touch-up.
