# BELZONA SCREED RESTORES DETERIORATED FLOORS

ID: 1112

Industry: Buildings & Structures  
Application: FPA-Floor Problem Areas  
Substrate: Concrete & Epoxy floor coating  
Products: <div>Belzona® 4131 (Magma Screed)</div>

Customer Location: Supermarket, British Columbia, Canada  
Application Date: 2007

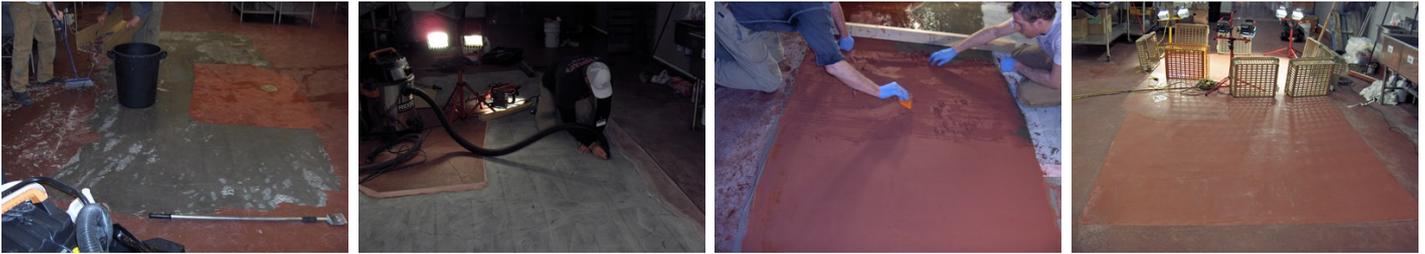
Water trapped underneath the failed coating was causing odour and health concerns.

\* The delaminated coating was removed with scrapers , \* The area was ground with a Vacu-Grinder , \* Application of Belzona Magma Screed in progress , \* Completed application with heat lamps in place . ,

The red epoxy floor coating was delaminating.

Application was carried out in accordance with Belzona Know-How System Leaflet FPA-1.  
Heat lamps were used to accelerate cure to ensure area ready for use following day.
