# BELZONA REBUILDS WASTEWATER PUMP IMPELLER

Customer Location: Water treatment plant, Des Moines, Iowa U.S.A.

Application: CEP-Centrifugal Pumps

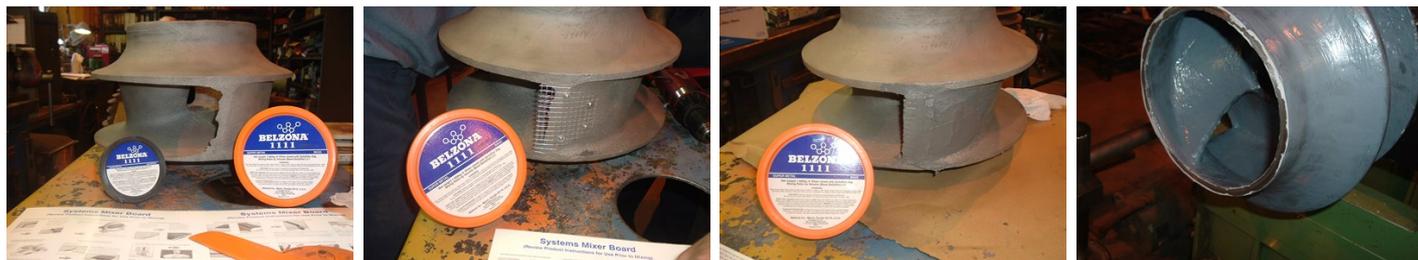
## Photograph Descriptions

The impeller was badly eroded and damaged due to grit and solids running through the pump

\* Damaged impeller after being baked and grit blasted , \* Impeller with wire mesh in place to support Belzona and help form profiles , \* Profiles restored with Belzona® 1111 , \* Rebuilt impeller being balanced ,

The applications was carried out in accordance with Belzona Know-How System Leaflet CEP-1 & -3.

Belzona was chosen to rebuild the impeller at a fraction of the replacement cost.
