# BELZONA PROVIDES LONG TERM REPAIR TO DEMIN PLANT FLOOR

ID: 1117

Customer Location: Power Utility, South Texas  
Application Date: January 2004

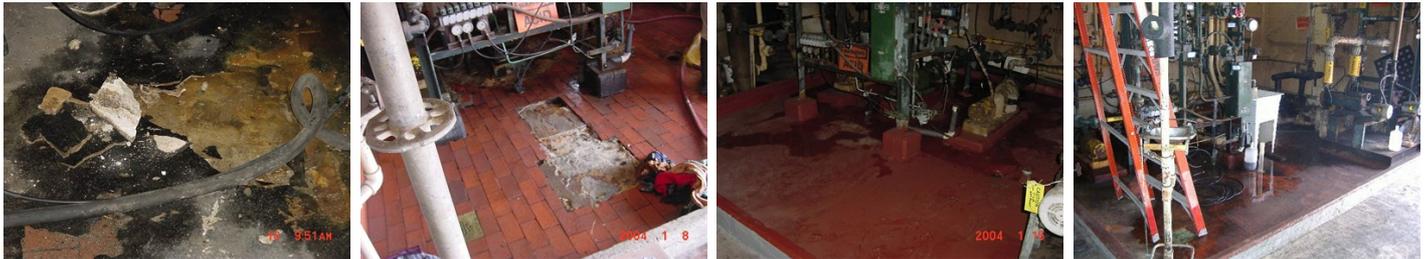
Old acid resistant bricks suffered chronic damage from acid and caustic leaks. Repair needed to restore floor integrity.

- \* Demin floor damage ,
- \* Floor cleaned and prepped ,
- \* Finished floor in January 2004 ,
- \* Demin floor June 2008 ,

Application was carried out in accordance with Belzona Know-How System Leaflets FPA-1 & FPA-3. Surface was cleaned, neutralized and blasted prior to conditioning and application of Belzona® 4181 and Belzona® 4111.

Client needed a solution to a containment problem. Area to be protected was uneven and rough. The mortar-like consistency of Belzona® 4181 made it ideal for this repair. After almost 4 1/2 years, application looks very good with no visible damage to the floor.
