BELZONA PROVIDES LONG TERM REPAIR TO DEMIN PLANT FLOOR

ID: 1117

Customer Location: Power Utility, South Texas
Application Date: January 2004

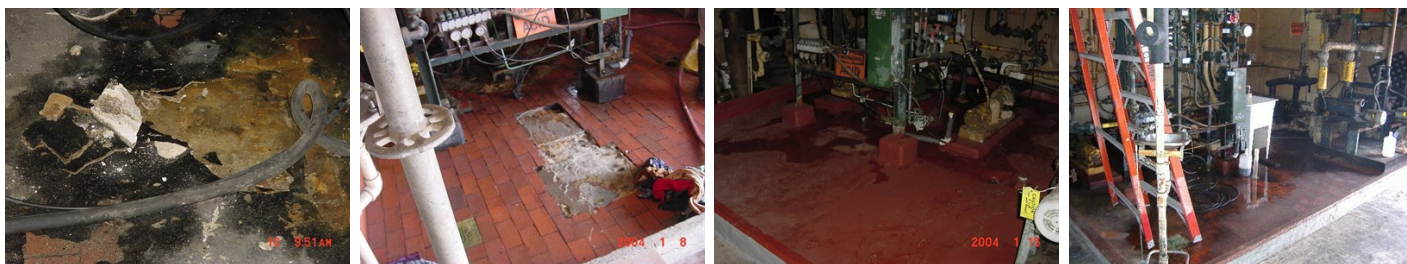
Photograph Descriptions

Old acid resistant bricks suffered chronic damage from acid and caustic leaks. Repair needed to restore floor integrity.

- * Demin floor damage ,
- * Floor cleaned and prepped ,
- * Finished floor in January 2004 ,
- * Demin floor June 2008 ,

Application was carried out in accordance with Belzona Know-How System Leaflets FPA-1 & FPA-3. Surface was cleaned, neutralized and blasted prior to conditioning and application of Belzona® 4181 and Belzona® 4111.

Client needed a solution to a containment problem. Area to be protected was uneven and rough. The mortar-like consistency of Belzona® 4181 made it ideal for this repair. After almost 4 1/2 years, application looks very good with no visible damage to the floor.
