BELZONA PROVIDES LONG LASTING PIPE SUPPORTS

Industry: Oil & Gas
Application: VPF-Valves, Pipes and Fittings
Substrate: Steel
Products: * Belzona® 1121 (Super XL-Metal) ,

Customer Location: International Oil Company
Application Date: February 1997

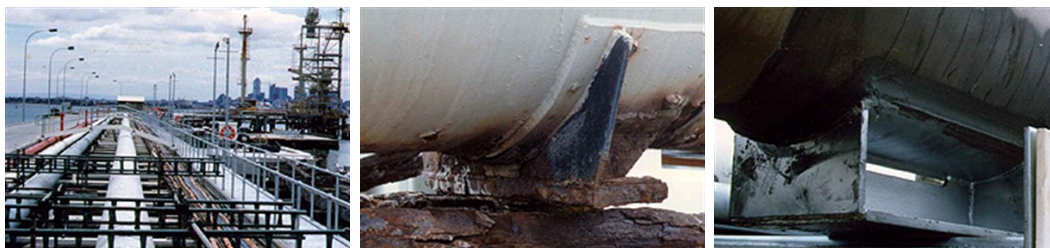
Severe corrosion of original pipe supports and pipe in way of support points.

- * General view of terminal ,
- * Typical corroded state of original supports ,
- * New saddle bonded in place prior to re-painting of the pipe ,

New pipe saddle supports and wear pads were bonded in place in accordance with Belzona Know-How Leaflet VPF-15.

Welding of new supports was not possible due to unloading of LPG and oil from tankers at regular intervals. Tests showed Belzona® 1121 provided corrosion resistant bond that required 25 tons to remove bracket.
