BELZONA GIVES NEW LIFE TO RUBBER ROOF

ID: 1120

Application: RPA-Roof Problem Areas

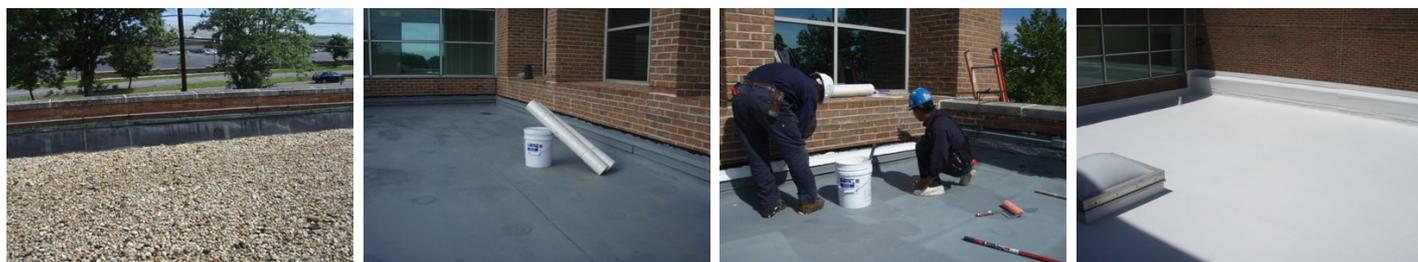
Photograph Descriptions

Roof had started to leak due to holes in the rubber membrane. The customer wanted the roof fixed quickly and without tearing off the old roof.

* Existing rubber roof with ballast rocks , * Rocks removed, membrane fastened and primed , * 1st coat of Belzona® 3111 applied , * Completed roof project ,

Application was carried out in accordance with Belzona Know-How System Leaflet RPA-6 & -8. The ballast was removed and the rubber membrane pressure washed. The rubber membrane was then mechanically fastened and rubber "peel-and-stick" pads were placed over each mechanical fastener washer. Fully reinforced Belzona Flexible Membrane System then applied using Belzona® 3921 as Conditioner.
