# BELZONA RESTORES STEEL MILL FLUME

**Industry:** General Industry  
**Application:** TCC-Tanks and Chemical Containment Areas  
**Substrate:** Concrete  
**Products:** <div>Belzona® 4124 (Bulk Fill)</div><div>Belzona® 4111 (Magma Quartz)</div><div>Belzona® 1812 (Ceramic Carbide FP)</div>

**Customer Location:** Steel Mill, USA  
**Application Date:** December 2007

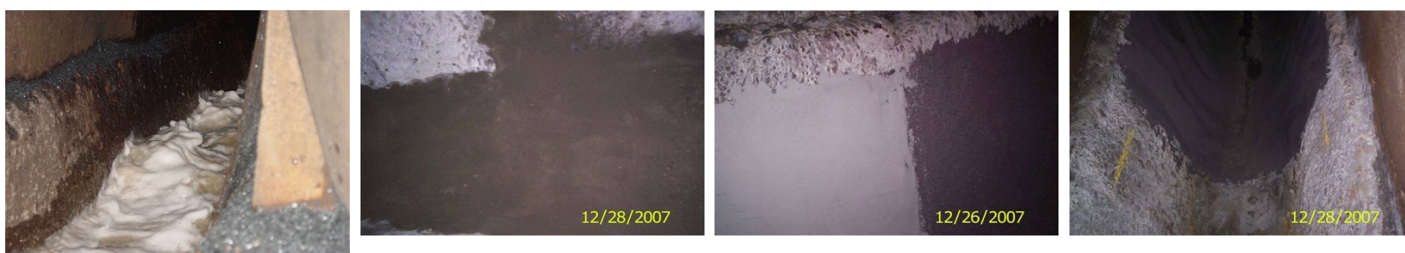
## Photograph Descriptions

Highly abrasive waste material was rapidly eroding the flume, carving out a larger cross-sectional area than original designed. Flow velocity dropped as a result and the flume was not longer functioning as designed thus allowing build up of waste within the flume.

- \* Trough prior to surface preparation ,
- \* Trough profile reformed with Belzona ,
- \* A further quarter inch of Belzona® 4111 applied ,
- \* Trough fully coated with Belzona® 1812 ,

Badly eroded waste flume at a steel mill.

Application was carried out in accordance with a modified Belzona Know-How System Leaflet TCC-9.
