# BELZONA PROTECTS CHEMICAL CONTAINMENT AREA

ID: 1135

**Customer Location:** Food Processing plant, France  
**Application Date:** June 2003

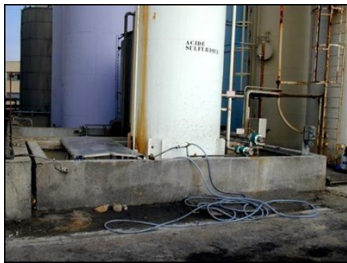
Heavy deterioration of the concrete due to leakage and contamination during maintenance operations. The integrity of the structure was compromised.

- \* View before repairs ,
- \* View of the tank supports ,
- \* View after shimming ,
- \* Application completed with Belzona® 4311 applied ,

Application was carried out in accordance with Belzona Know-How System Leaflet TCC-15. Special attention given to shimming and protecting base of support steelwork.
