BELZONA PROTECTS CHEMICAL CONTAINMENT AREA

ID: 1135

Customer Location: Food Processing plant, France
 Application Date: June 2003

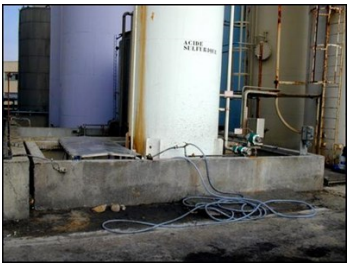
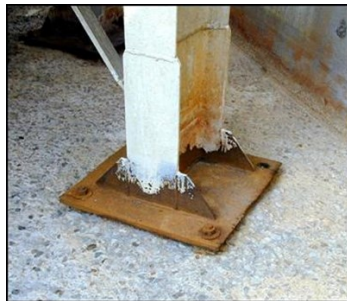
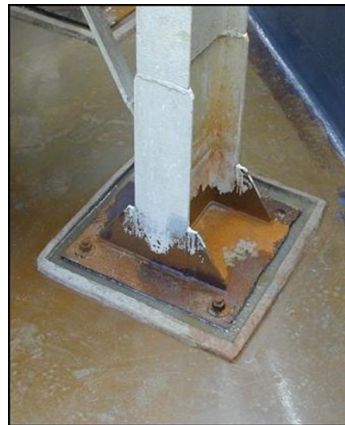
Photograph Descriptions

Heavy deterioration of the concrete due to leakage and contamination during maintenance operations. The integrity of the structure was compromised.

- * View before repairs ,
- * View of the tank supports ,
- * View after shimming ,
- * Application completed with Belzona® 4311 applied ,

Application was carried out in accordance with Belzona Know-How System Leaflet TCC-15. Special attention given to shimming and protecting base of support steelwork.

Area brought up to standard to meet required regulations. Additional protection for supports. Repairs easily carried out if required.
Durable: During the last inspection in 2009, the containment area was in perfect condition.
