# BELZONA PROTECTS CHEMICAL CONTAINMENT AREA

ID: 1135

Customer Location: Food Processing plant, France  
 Application Date: June 2003

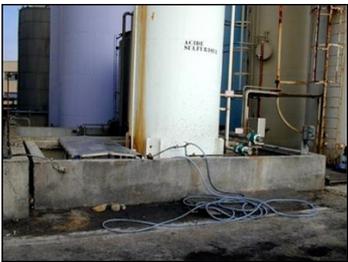
Heavy deterioration of the concrete due to leakage and contamination during maintenance operations. The integrity of the structure was compromised.

- \* View before repairs ,
- \* View of the tank supports ,
- \* View after shimming ,
- \* Application completed with Belzona® 4311 applied ,

Application was carried out in accordance with Belzona Know-How System Leaflet TCC-15. Special attention given to shimming and protecting base of support steelwork.
