# BELZONA SEALS LOCAL ROOF PROBLEM

ID: 1139

Customer Location: Military Base, Oklahoma  
Application Date: May, 2008

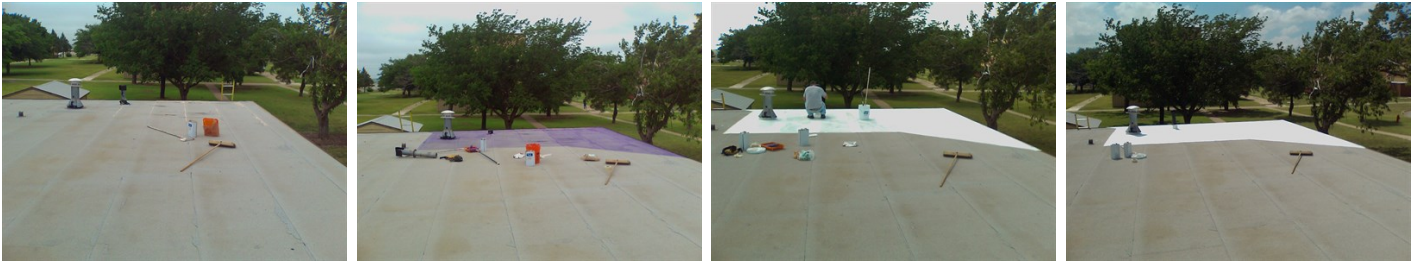
Building was being refurbished inside and the roof was leaking in the corner halting the interior work.

- \* Leaking section of roof after washing and drying ,
- \* Belzona® 3911 (PSC Conditioner) applied ,
- \* First coat of Belzona® 3111 incorporating reinforcing sheet applied ,
- \* Completed roof repair and leak free ,

Application was carried out in accordance with Belzona System Leaflets RPA-1,2 & 7. A fully reinforced Belzona® 3111 system was applied to the corner of the roof where leaks were identified.

Repair was done in one day and was leak-free by the next morning when a storm came in. The Belzona system is ideal for localized repair, where its excellent adhesion ensures no peel-back for edges.
