BELZONA SEALS LOCAL ROOF PROBLEM

ID: 1139

Customer Location: Military Base, Oklahoma
Application Date: May, 2008

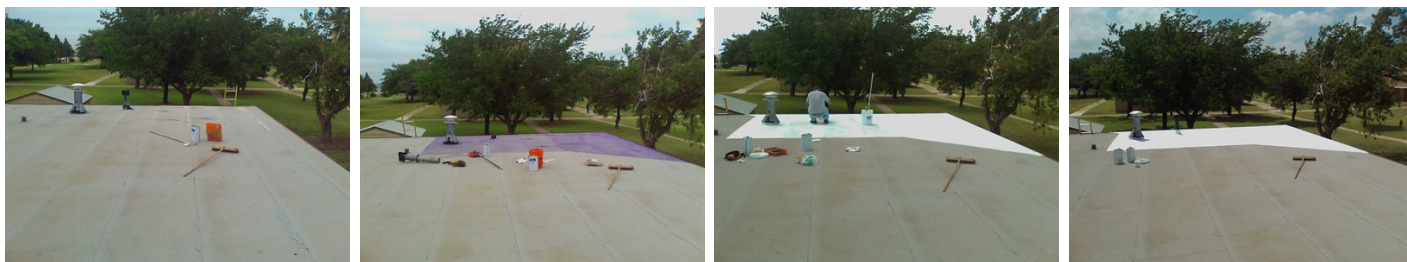
Photograph Descriptions

Building was being refurbished inside and the roof was leaking in the corner halting the interior work.

- * Leaking section of roof after washing and drying ,
- * Belzona® 3911 (PSC Conditioner) applied ,
- * First coat of Belzona® 3111 incorporating reinforcing sheet applied ,
- * Completed roof repair and leak free ,
- ,

Application was carried out in accordance with Belzona System Leaflets RPA-1,2 & 7. A fully reinforced Belzona® 3111 system was applied to the corner of the roof where leaks were identified.

Repair was done in one day and was leak-free by the next morning when a storm came in. The Belzona system is ideal for localized repair, where its excellent adhesion ensures no peel-back for edges.
