# BELZONA® MENDS HOLE FROM ASH DUST

Customer Location: Coal fired power plant in Alabama,  
U.S.A.

Fan housing

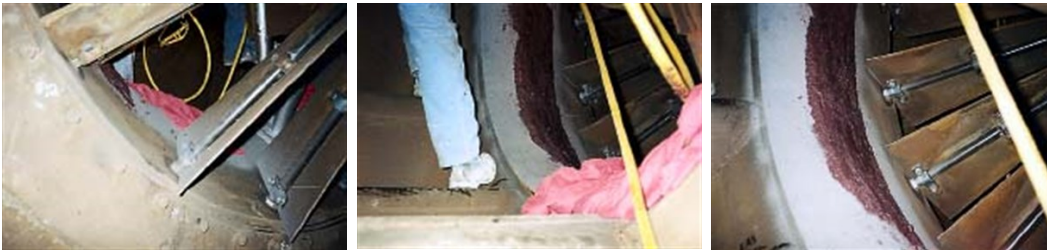
Hole worn through metal caused by abrasive ash dust.

1. Work commenced at night.
2. The hole is mended with Belzona® 1811.
3. Close-up view of the repaired area.

Application was carried out in accordance with Belzona Know-How Leaflets FBC-4 and FBC-5.

Replacement of the fan housing would take 13 days and \$50,000. The Belzona repair was accomplished in-place for \$6,000 in product and saved the power plant many hours in downtime.
