BELZONA SEALS SKYLIGHTS ON JET HANGER

ID: 1140

Application: *RPA-Roof Problem Areas*

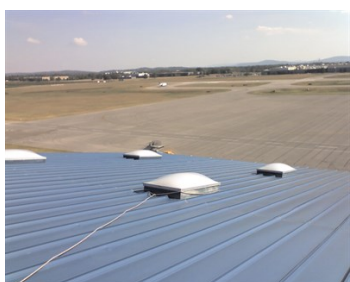
The roof of the hanger has 16 skylights and each one leaked. Several earlier attempts to seal skylights proved futile.

* Skylights with runways in background , * Taped off and ready to coat , * Belzona® 3111 1st coat going on , * Finished job. No leaks - no problems! ,
