BELZONA REFURBISHES MILITARY DOG KENNELS

ID: 1142

Application: *FPA-Floor Problem Areas*

Customer Location: *Military Base, North Alabama*

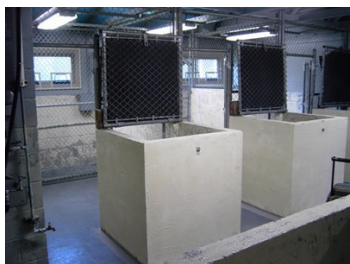
* Prepped and ready to coat , * Floor and coves covered , * Almost complete, walls being coated , * All done! Ready to turn over to the owners ,

To create a non-slip surface that did not damage paws, different aggregates were tried before settling on a non-standard Belzona one that was found to be ideal. Coves between wall and floor were formed and Belzona® 5111 provided stain resistant finish.
