# BELZONA CALLED TO FIX FAILED COATING

ID: 1143

Application: TCC-Tanks and Chemical Containment Areas

Substrate: Reinforced Concrete

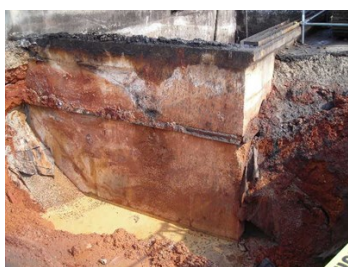
The leak turned out to be a hole measuring 36" x 48" and cut completely through the 8" thick wall. Rebar had to be tied back in and the wall needed to be rebuilt to specification. The plant was still in operation, so the acids were diverted to holding tanks and taken off site for processing...an expensive and tedious process.

\* The size and scope of a small Leak , \* The failed coating , \* External view after preparation , \* Finishing touches ,

The repair required a form built on the outside so Belzona® 4111 & 4141 could be packed into the hole. Several smaller holes were discovered inside and out. Each repair was then covered with 2 coats of Belzona® 4301.
