BELZONA CALLED TO FIX FAILED COATING

Customer Location: Chemical Plant, North Alabama U.S.A.

Application: TCC-Tanks and Chemical Containment Areas

Substrate: Reinforced Concrete

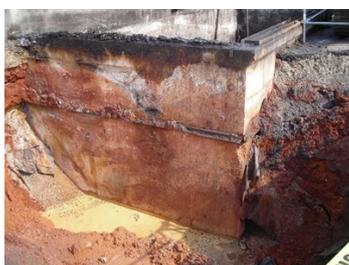
The leak turned out to be a hole measuring 36" x 48" and cut completely through the 8" thick wall. Rebar had to be tied back in and the wall needed to be rebuilt to specification. The plant was still in operation, so the acids were diverted to holding tanks and taken off site for processing...an expensive and tedious process.

* The size and scope of a small Leak , * The failed coating , * External view after preparation , * Finishing touches ,

Small leak in the wall of an acid pit. The leak was below ground and the pit walls had to be excavated, shored up, scaffolding, extreme safety measures involving several contractors...all due to a competitors coating failure.

The repair required a form built on the outside so Belzona® 4111 & 4141 could be packed into the hole. Several smaller holes were discovered inside and out. Each repair was then covered with 2 coats of Belzona® 4301.
