BELZONA SEALS UPPER FLOOR PUMP ROOM

ID: 1145

Industry: *Buildings & Structures*
Application: *TCC-Tanks and Chemical Containment Areas*
Substrate: *Concrete*
Products: *Belzona® 5811 (Immersion Grade)*

Customer Location: *County Hospital, Colton California U.S.A.*
Application Date: *2007*

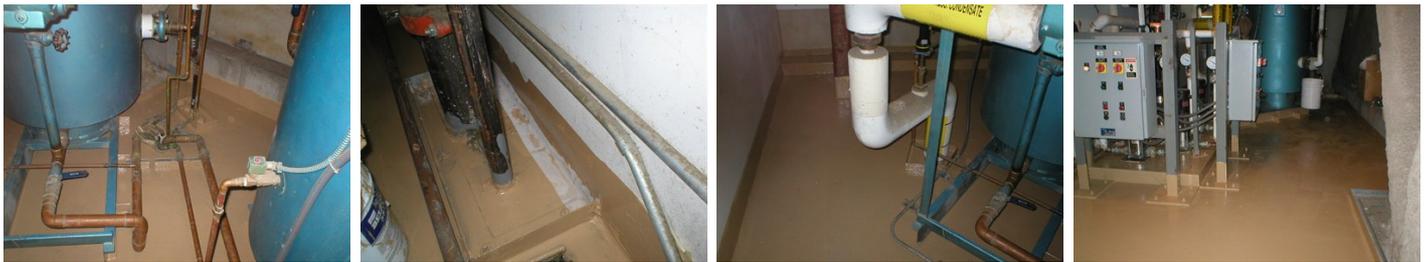
Photograph Descriptions

Copper pipes leaking water on the floor was leaking through the concrete to the lower level.

* The pump room showing the pipes that keep leaking , * Reinforcement tape used for edges , * Back of pump room , * Finished floor ,

Application was carried out using a modified Belzona Know-How System TCC-15.

After washing and removing dirt from floor Belzona® 5811 was used to coat the entire floor plus 6 inches up the wall to completely encapsulate the area and to form a containment area.
