# BELZONA SEALS UPPER FLOOR PUMP ROOM

ID: 1145

Industry: *Buildings & Structures*  
Application: *TCC-Tanks and Chemical Containment Areas*  
Substrate: *Concrete*  
Products: *Belzona® 5811 (Immersion Grade)*

Customer Location: *County Hospital, Colton California U.S.A.*  
Application Date: *2007*

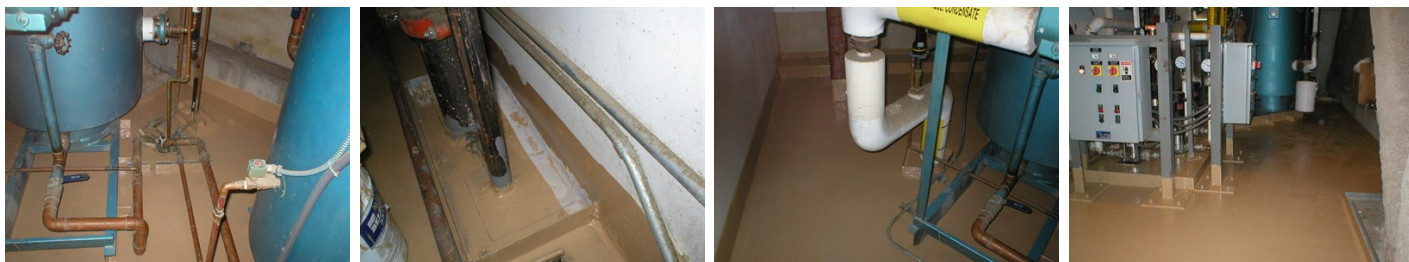
## Photograph Descriptions

*Copper pipes leaking water on the floor was leaking through the concrete to the lower level.*

\* The pump room showing the pipes that keep leaking , \* Reinforcement tape used for edges , \* Back of pump room , \* Finished floor ,

Application was carried out using a modified Belzona Know-How System TCC-15.

After washing and removing dirt from floor Belzona® 5811 was used to coat the entire floor plus 6 inches up the wall to completely encapsulate the area and to form a containment area.
