# BELZONA REPAIR TO CONCRETE STOCK CHEST

ID: 1146

Customer Location: Containerboard Paper Mill, North Alabama, U.S.A.

Application: TCC-Tanks and Chemical Containment Areas

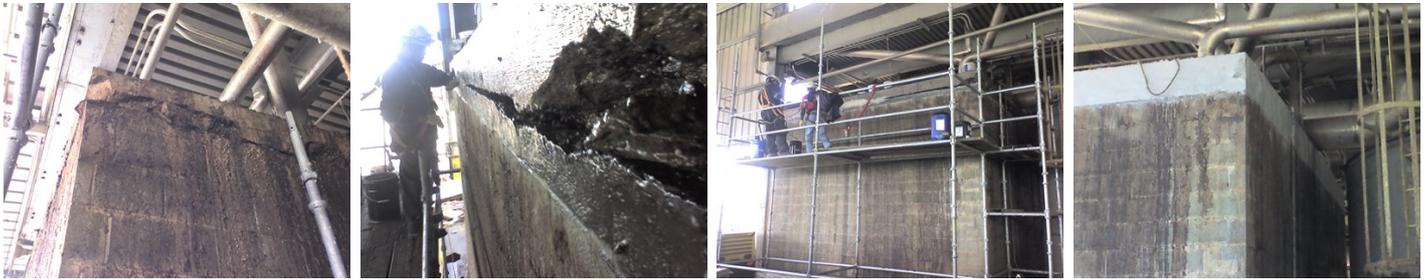
## Photograph Descriptions

The top not only lifted, it blew chunks out of the sides all the way around. Job was to fill in the the voids created by the stock and to seal the edges against further leaking.

\* View of the Damage from below , \* Area being prepared and void packed , \* Work underway , \* Finished application ,

Concrete block tank holding stock being fed to the #1 Paper Machine. It has a pressure release valve to allow blow-by in case of emergencies and it failed. The pressure grew to the point that the solid, reinforced concrete lid lifted and stock blew out the sides.

This application was carried out in accordance with Belzona Know-How System Leaflet TCC-9 and WPA-4. The area was grit blasted to remove stock and prepare the concrete. Deeper areas were filled with Belzona® 4141 and Belzona® 4111 was used over the entire outer surface to ensure containment.
