BELZONA REPAIRS BROKEN INSULATORS

ID: 1147

Customer Location: Power Distribution company, France

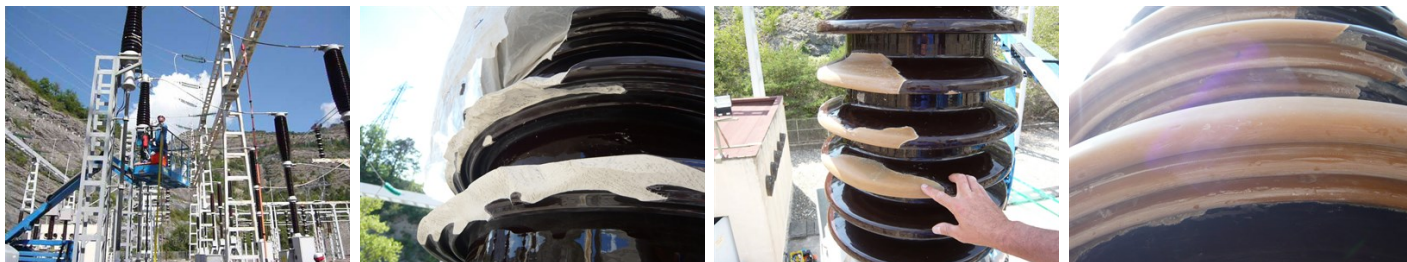
Photograph Descriptions

Broken insulator, compromising safety on site.

* General view of the sub-station , * Broken insulator , * Repair completed , * Close up showing exact reproduction of the original profile ,

Pattern for the broken area taken from sound area using Belzona Elastomer. This then used to mold Belzona® 8111 to re-create original profiles

The option of repairing with Belzona® 8111 has been chosen because of the electrical properties of the product.

The repair was done on site by the application team, who completed the job in a few hours.
