# BONDING FAIRLEADS WITH BELZONA

ID: 1148

Customer Location: Shipyards, France  
Application Date: May 2008

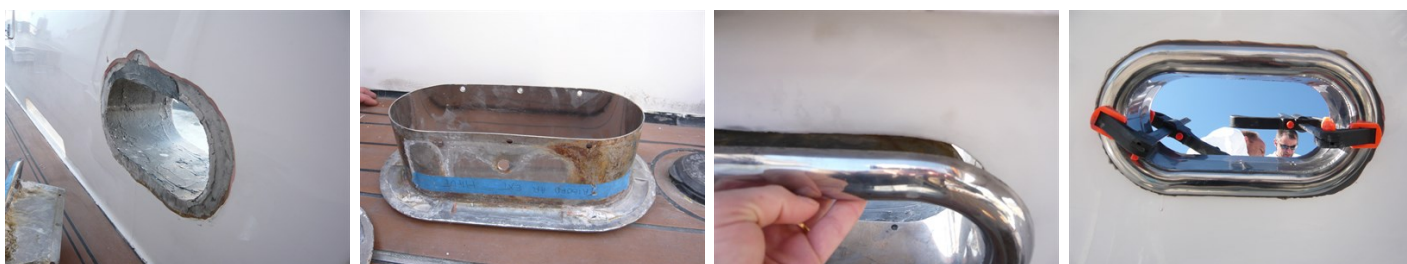
## Photograph Descriptions

Fairleads have been dismantled in order to realise repairs to the hull. A rebuilding and bonding material was then necessary to fill gaps when fairleads were replaced.

- \* Fairlead pocket ,
- \* Fairlead before application ,
- \* Application underway ,
- \* Fairlead clamped in place during the cure process ,

Application was carried out in accordance with a modified Belzona Know How System GSS-9.

The pourable chocking option usually considered by the customer could not be applied in this situation due to the thickness of adhesive required. Belzona® 1111 has no limitation in thickness when applied in such an environment,
