# Belzona to the Rescue for Higher Learning

Customer Location: *University Central Energy Plant -  
Laramie, Wyoming USA*

Application: *CEP-Centrifugal Pumps*

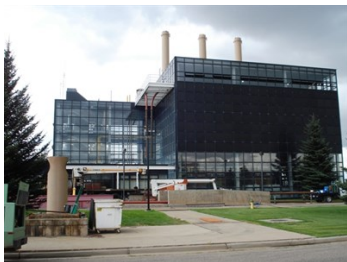
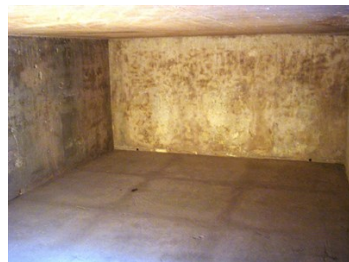
*After one short year in service, the original coating was delaminating in large sheets exposing the concrete and rebar to the corrosive action of the hot condensate.*

- \* Central energy plant ,
- \* Condensate tank after abrasive blasting ,
- \* Belzona® 1391 after pinhole testing ,
- \* Belzona application two years later requiring minor touchup due to substrate degradation ,

Belzona® 1391 and Belzona® 1511 were applied in accordance with a modified version of Belzona Know-How System Leaflet VPF-2.

The original failed coating was discovered with only four days remaining in the annual shutdown. Belzona was easily able to recoat the tank in this limited timeframe and to date has given two years of trouble-free service.
