# BELZONA CONTAINER SHIP RUDDER REPAIRS

ID: 116

Industry: *Marine*  
Application: *SOS-Ships and Offshore Structures*

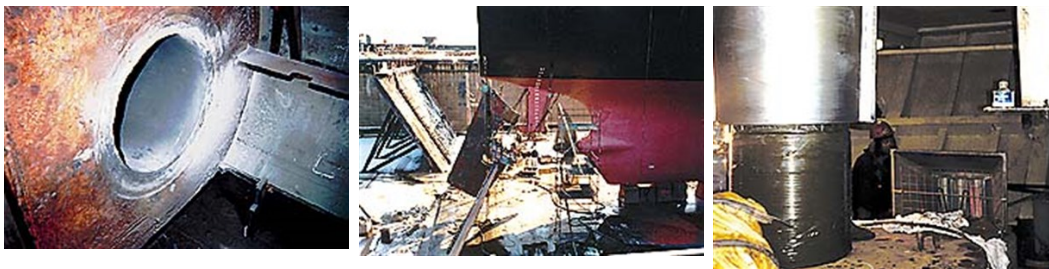
## Photograph Descriptions

*Very severe erosion/corrosion of steel components of the ship's rudder*

- \* Pintle pin bore after molding, 95-99% contact per ABS Surveyor ,
- \* Rudder being installed on ship after pintle pin repairs ,
- \* Rudder stock bore with Belzona® 9411 (Release Agent) ,

The application was carried out in accordance with Belzona Know-How Leaflets SOS-3 and MPT-1.

Conventional repairs using only welding and machining/field boring would have required a very long stay in drydock, causing severe disruption of cargo schedule with huge losses.
