BELZONA® 4181 SOLVES NEUTRALIZATION PROBLEM

Customer Location: Chemical Plant, North Alabama U.S.A.

Application: TCC-Tanks and Chemical Containment Areas

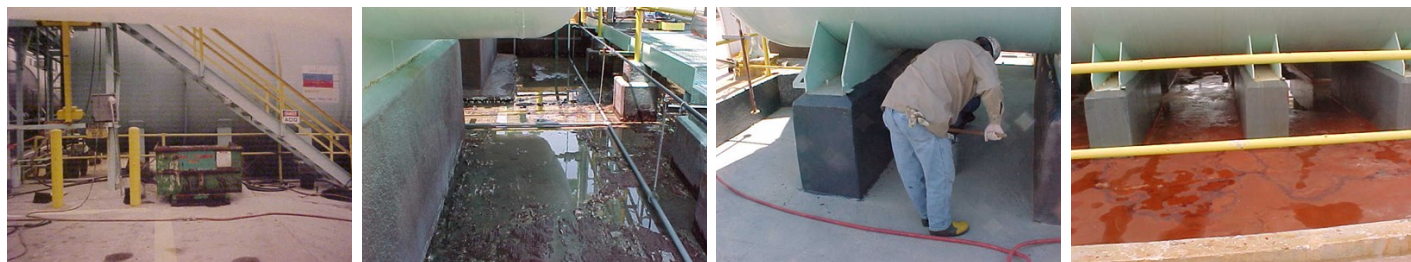
Photograph Descriptions

Spill of 98% sulfuric acid was neutralized with caustic. The exotherm badly damaged the coating applied 2 years previous.

* Overview of the sulfuric acid containment area , * Deteriorated coating after the caustic was added to the acid spill , * New concrete poured and pedestals coated with Belzona® 4311 , * Finished project with Belzona® 4181 and perfect after 8 years ,

Damage concrete removed and 3 inch of new concrete poured to level base.

Belzona® 4181 used on floor and Belzona® 4311 on walls.
